Rimkus Consulting Group, Inc.
Eight Greenway Plaza, Suite 500
Houston, TX 77046
(800) 580-3228 Telephone
(713) 623-4357 Facsimile

Re: RCG File No: 11009971
LLV Number: 0209452
VMF Location: 1530 Greensmark Drive in Houston, Texas
Subject: Final Report

Rimkus Consulting Group, Inc. was retained to examine LLV 0209452, VIN 1GBCS10E4M2908832. The fire occurred on June 13, 2016 at around 12:30 P.M. the operator of the vehicle at the time of the fire, was unavailable for interview but reportedly stated the vehicle's engine died while delivering mail on his route and backfired during subsequent attempts to restart it. Soon thereafter, smoke was observed from beneath the hood as well as flames.

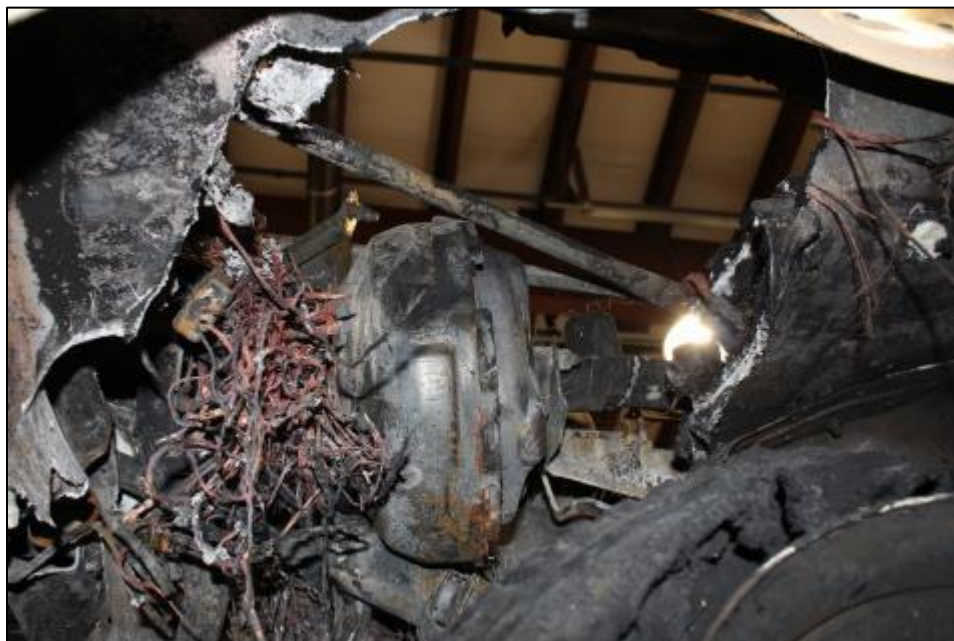
Photograph 18

View from driver's side wheel up into engine compartment.

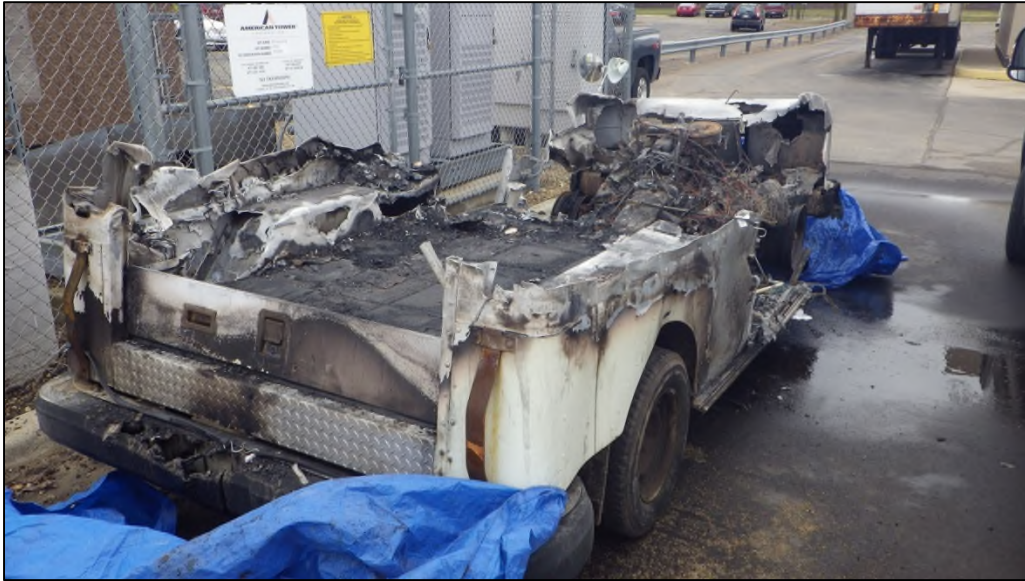
Photograph 1
LLV exterior.

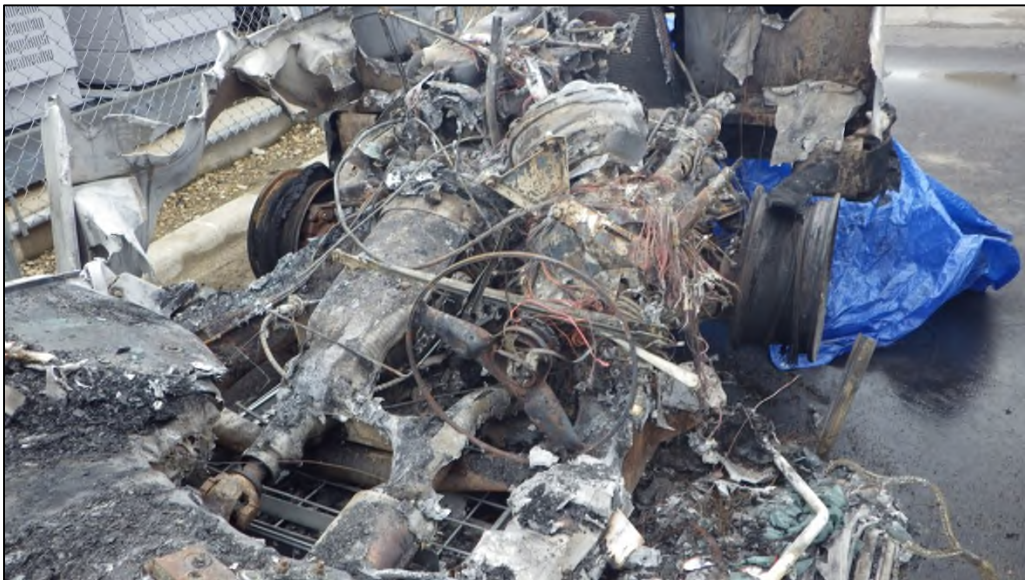
Photograph 2
LLV operator's compartment.

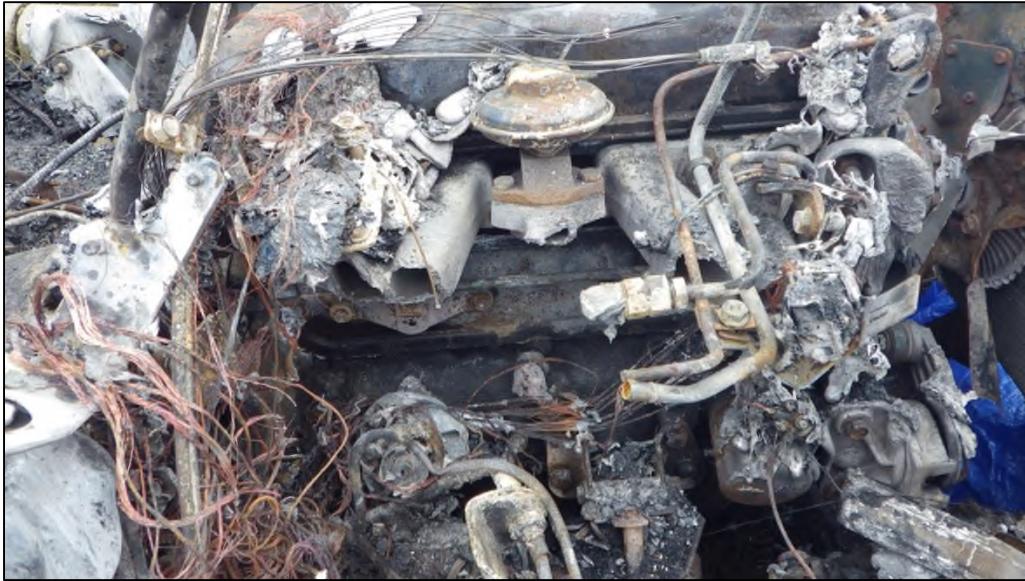
Photograph 3

Engine, area of greatest fire damage.

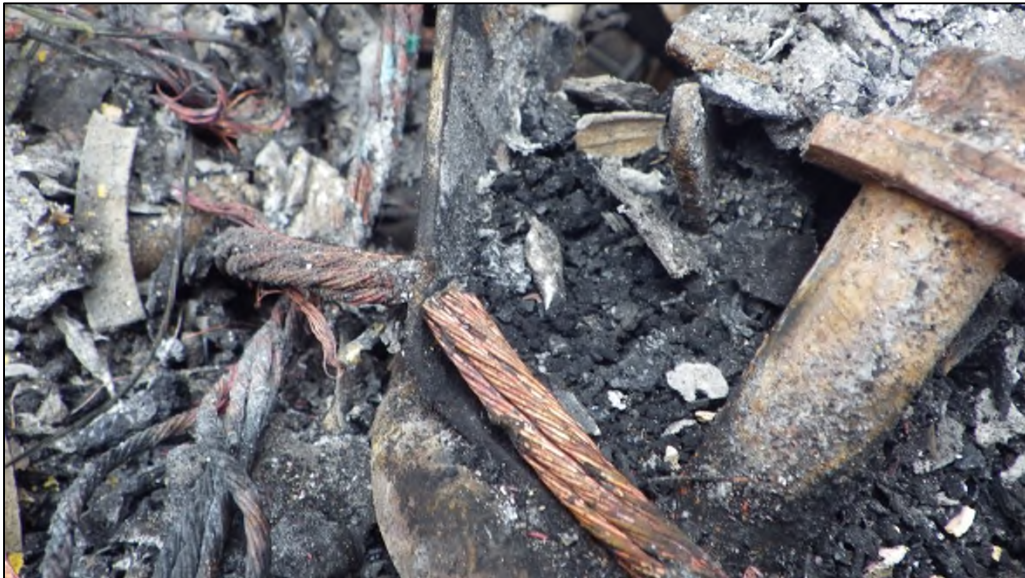
Photograph 4

Positive battery cable arc to motor mount.

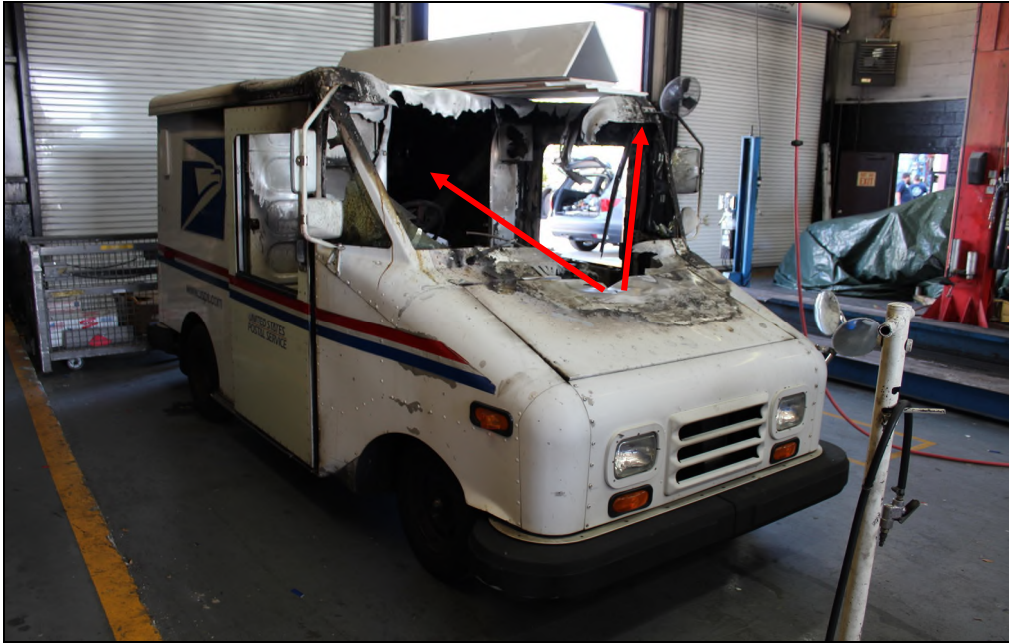
Photograph 1

View of the front, driver's side of LLV 9210245. Note the radial fire pattern on the hood and that the fire patterns are extending from the rear of the engine compartment and interior dashboard.

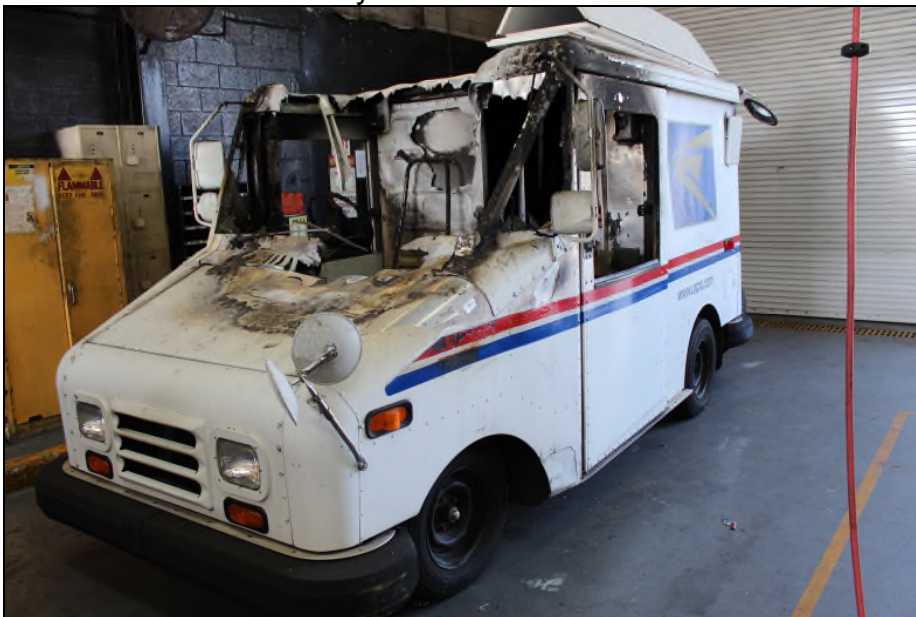
Photograph 2

View of the mail side of the LLV. Note the windshield and roof above the operator's compartment were consumed by the fire.

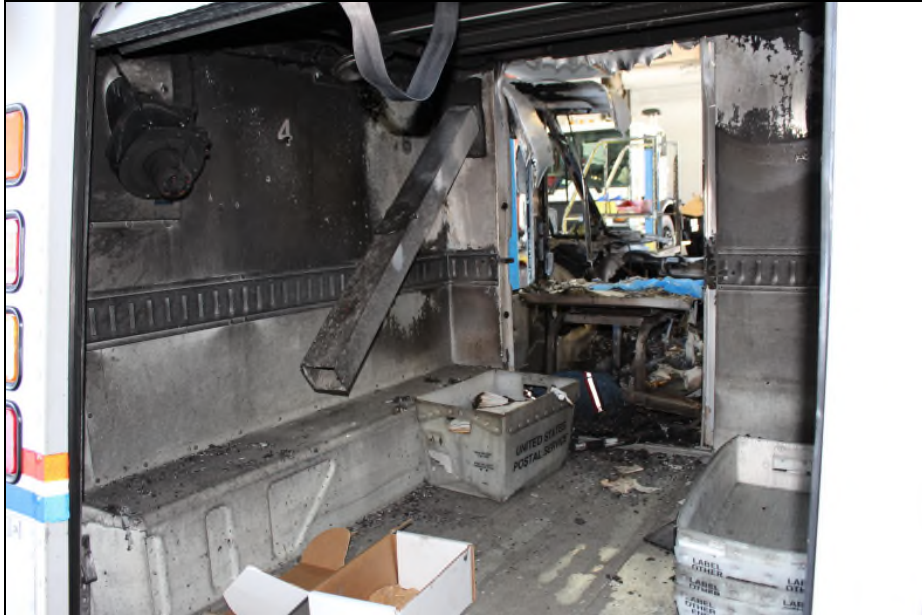
Photograph 3

View of the cargo compartment.

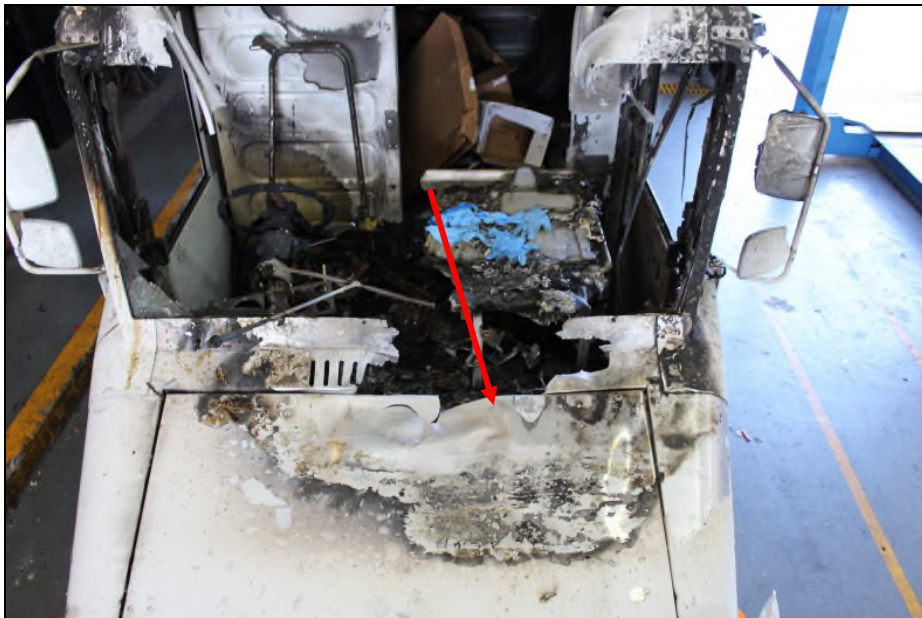
Photograph 4

View from above showing the burn through hole directly above the dashboard indicating the area of origin.

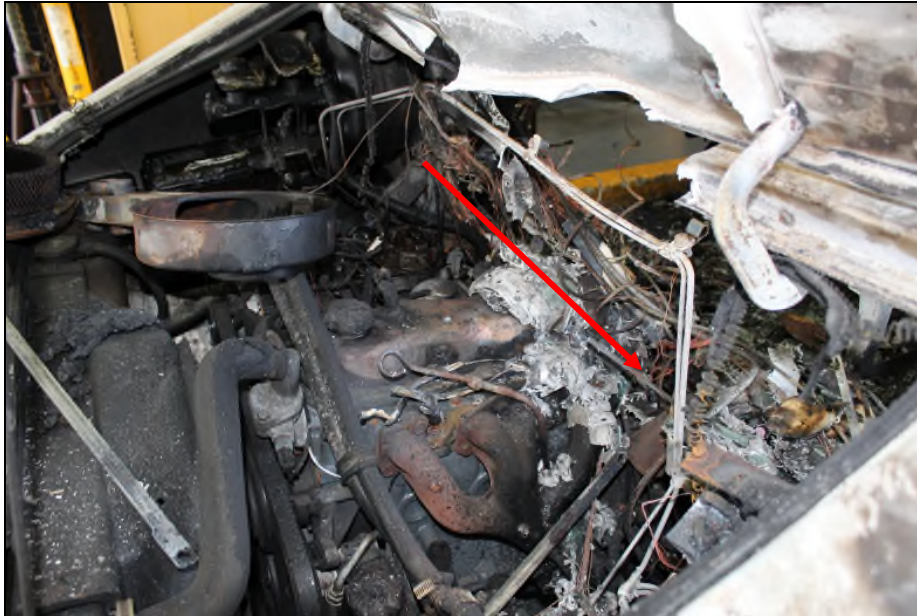
Photograph 5

View of the engine compartment. Note that most of the components are intact and the majority of the damage is at the rear of the engine.

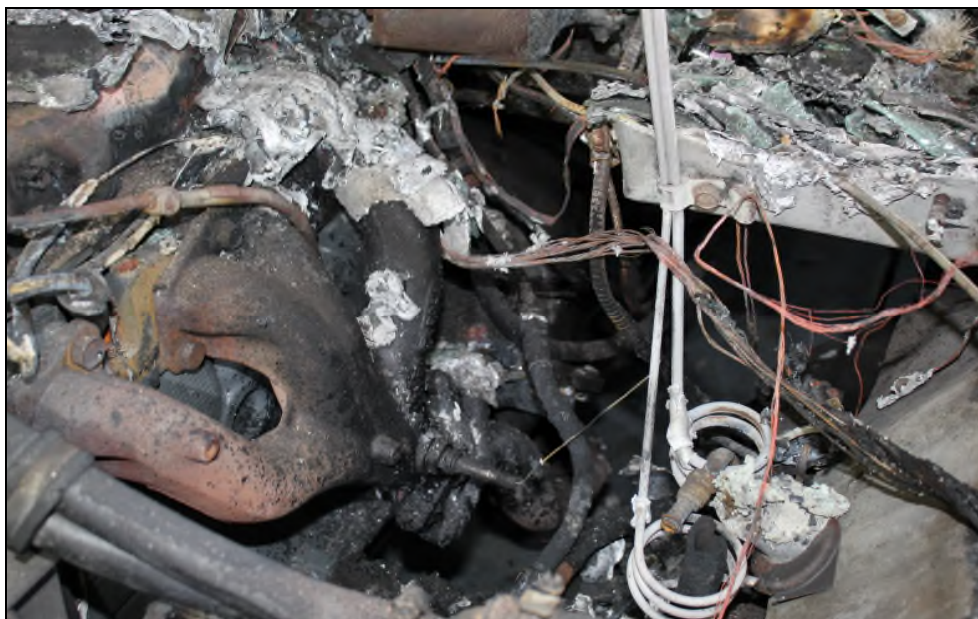
Photograph 6

Closer view of the area with the most severe fire damage in the engine compartment. Note that although evidence of oil is observed, the rubber hoses are mostly intact indicating the fire extended to this area from the operator's compartment.

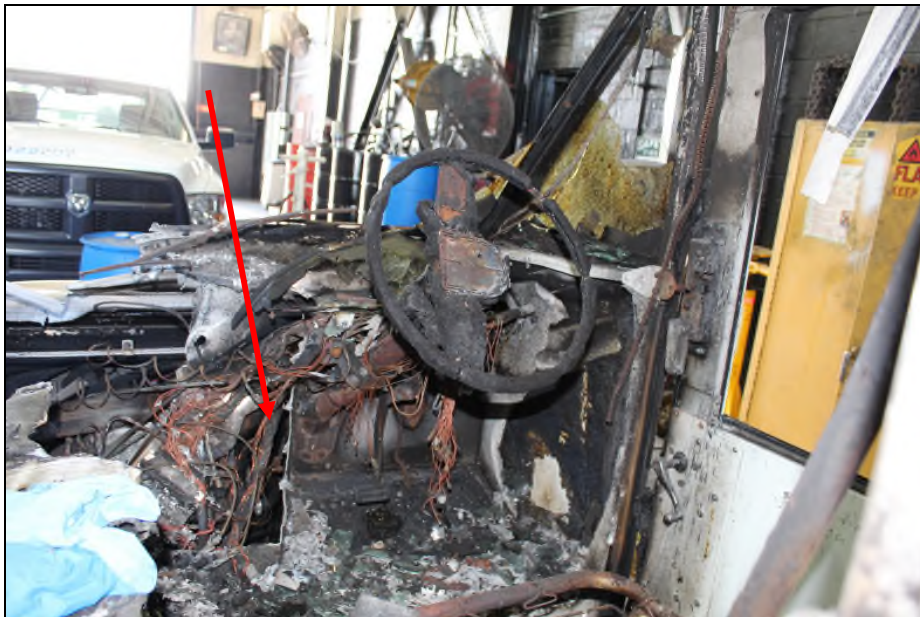
Photograph 8

View of the driver's side of the operator's compartment. Note the aluminum bulkhead is still intact on this side and is melted through towards the center of the vehicle.

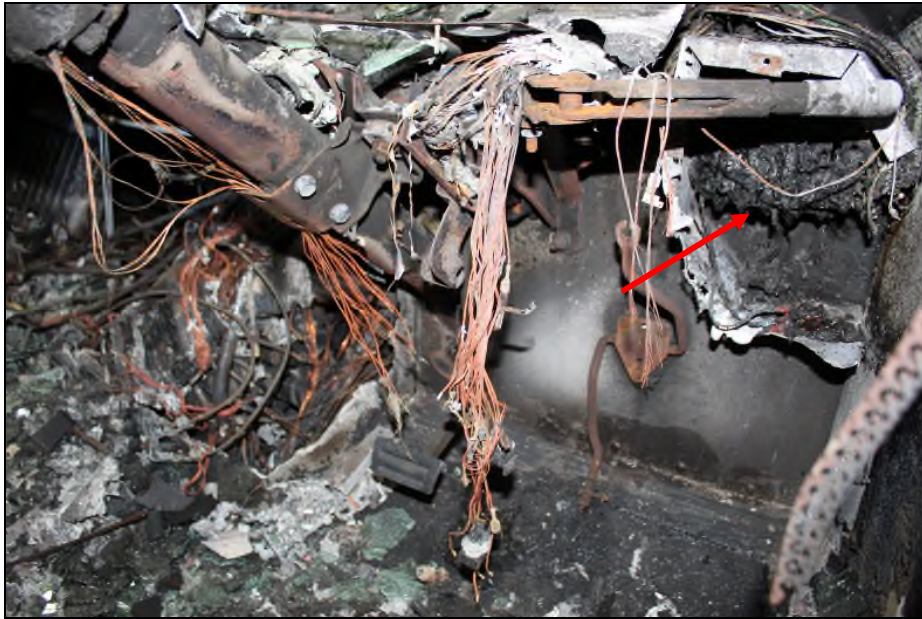
Photograph 9

View of the underside of the dashboard on the driver's side. Note the fuse panel is severely melted but still has combustible material remaining.

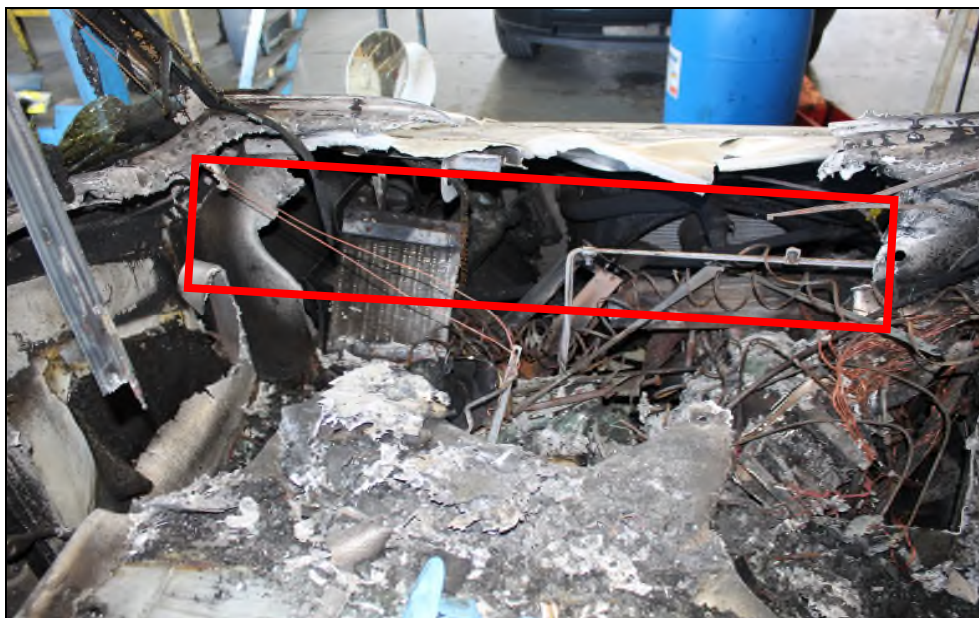
Photograph 10

Another view of the mail side of the operator's compartment. Note the bulkhead melted and was burned through to the engine compartment. Note the position of the dashboard had occupied with various electrical conductors inside.

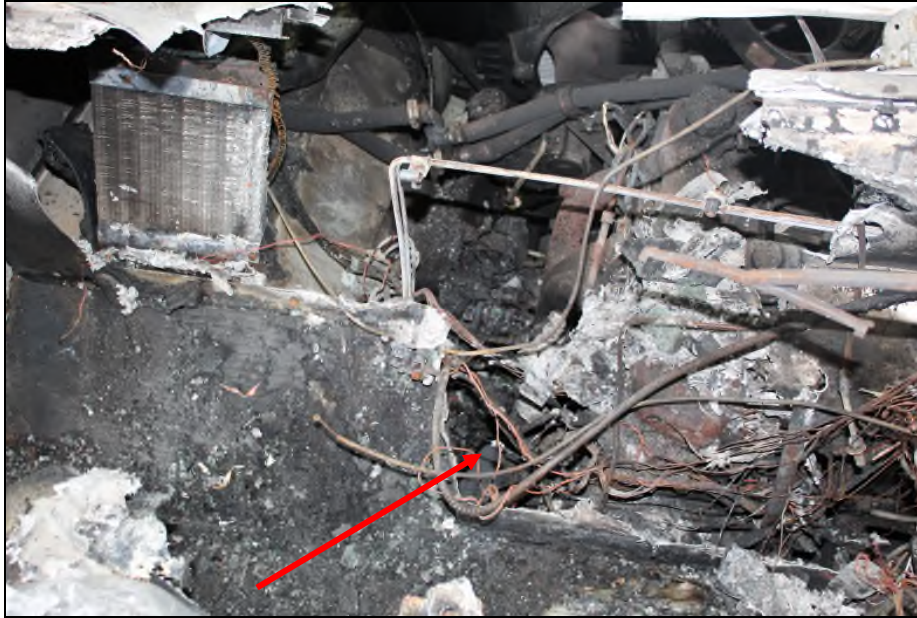
Photograph 11

Closer view of the area of origin showing the severe fire damage in the area. Note the fire damage is less severe in the engine compartment.

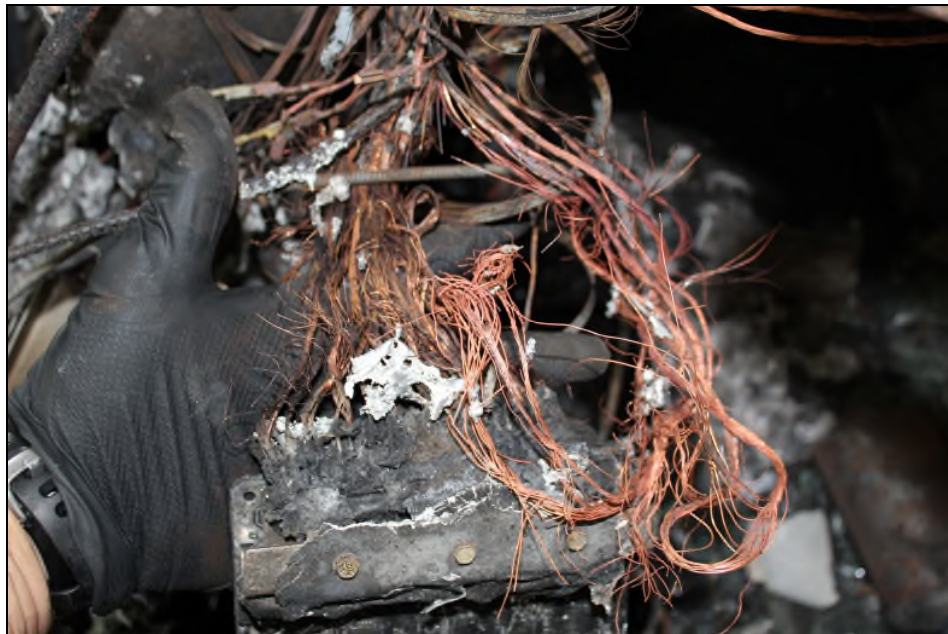
Photograph 12

View of the severe fire damaged ECM and connecting electrical conductors. The ECM was positioned below the dashboard in the area of origin.

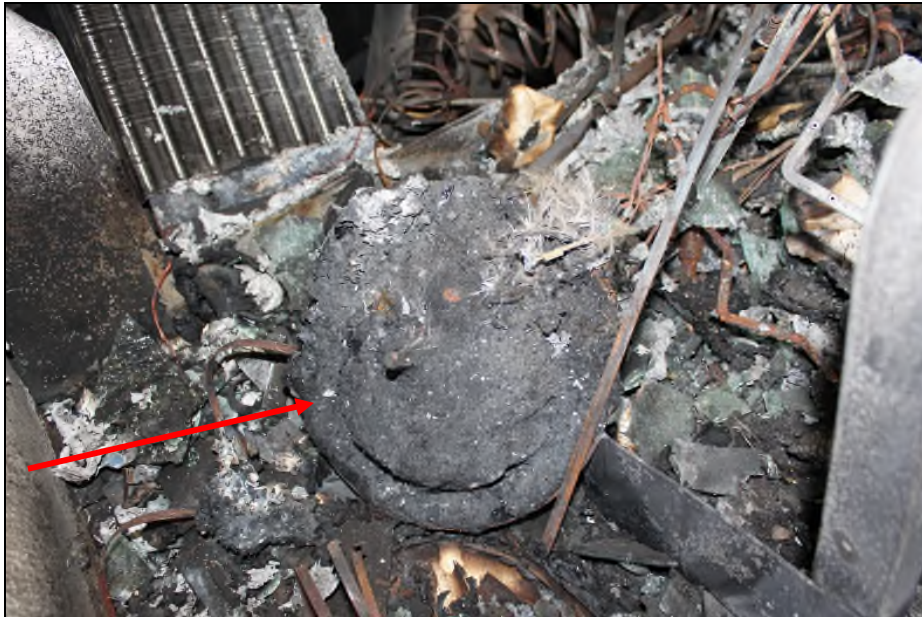
Photograph 13

View of the remnants of the heater blower motor.

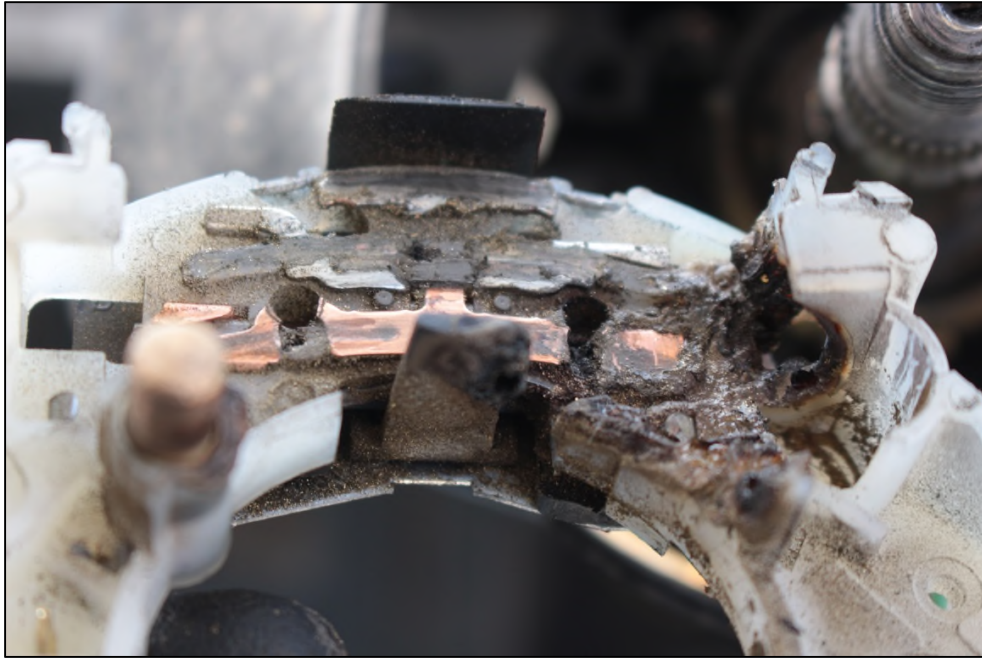
Photograph 3

3. The specific ignition sequence and cause of the fire was determined to be the direct result of a failure of the upper steering column bearing located at the turn signal switch within the steering column which heated and ignited surrounding combustible material.

Examination of the area of origin, located within the steering column at the turn signal assembly, revealed a small area of fire damage to the switch.

Origin at turn signal assembly.

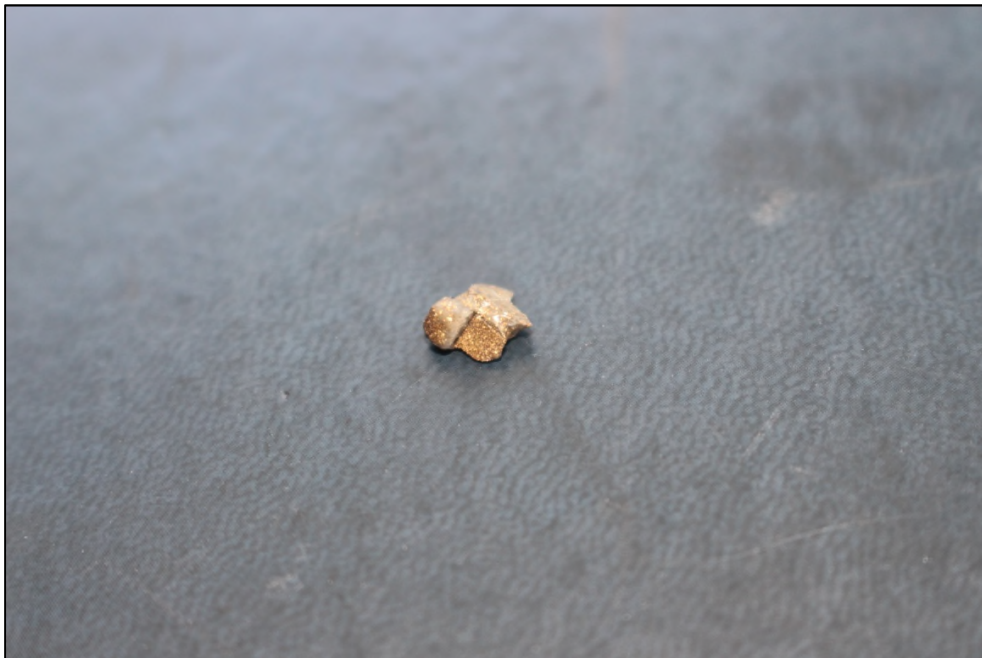
Photograph 4

Evidence of accumulated metal particles, which appeared to be of brass, were observed inside and around the upper steering column bearing and turn signal assembly. These metal particles resembled those produced by using a file to smooth or form metal. Observations indicated the upper steering column bearing at the turn signal assembly and metal horn button, which was held in contact to the horn grounding ring assembly with spring pressure, appeared to have filing marks and brass shavings from the upper steering column bearing. In addition, the metal portion of the horn grounding ring may have also produce metal particulates due to the friction contact with the horn grounding button.

A molten nugget of this metal particulate was found in the turn signal assembly, and may have provided a high resistance path for an electrical short or ground fault. Examination and evaluation by an electrical engineer is recommended.

Molten metal particulate nugget from the turn signal assembly.

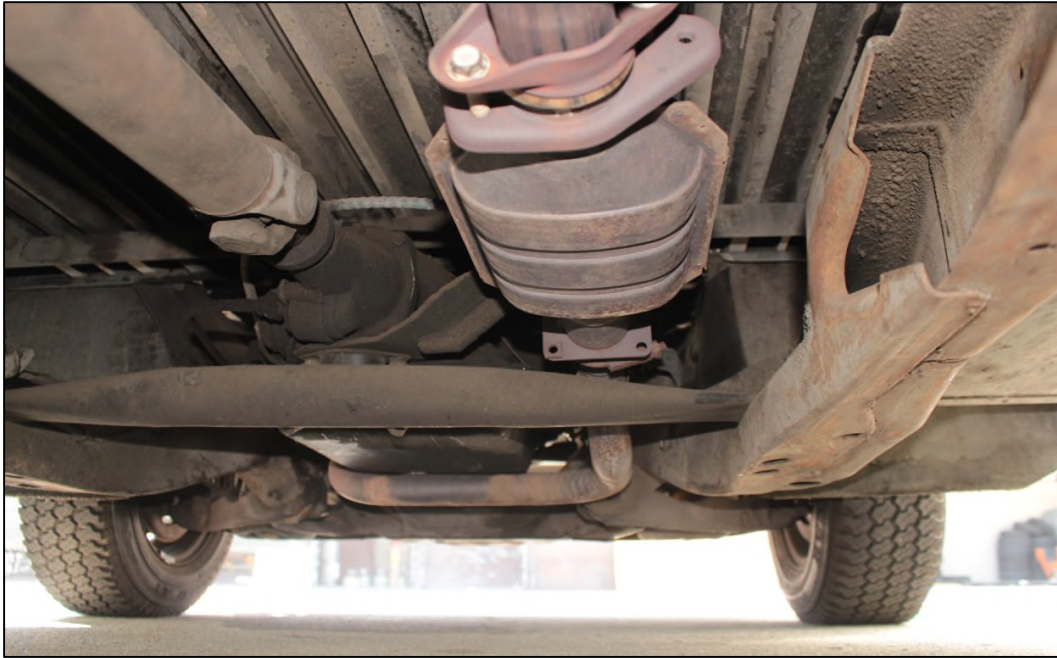
Examination of the undercarriage revealed no damage. The LLV was mounted on a GM frame and was undamaged. The fuel tank and fuel lines did not show any signs of failure. The exhaust system was intact.

Photograph 5
Undercarriage.

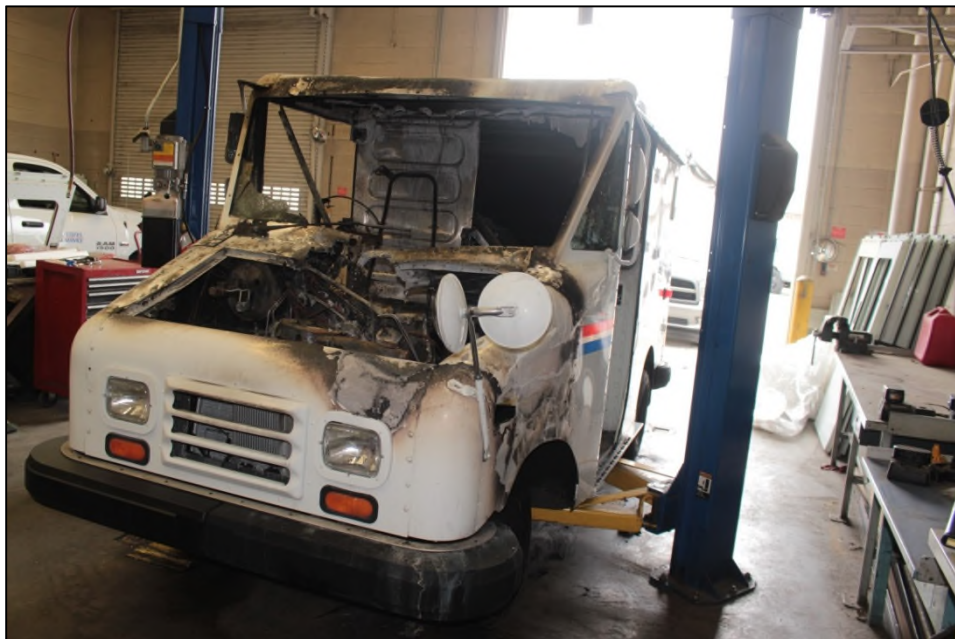
Photograph 2

Severe fire damage to the engine compartment and driver's compartment areas.

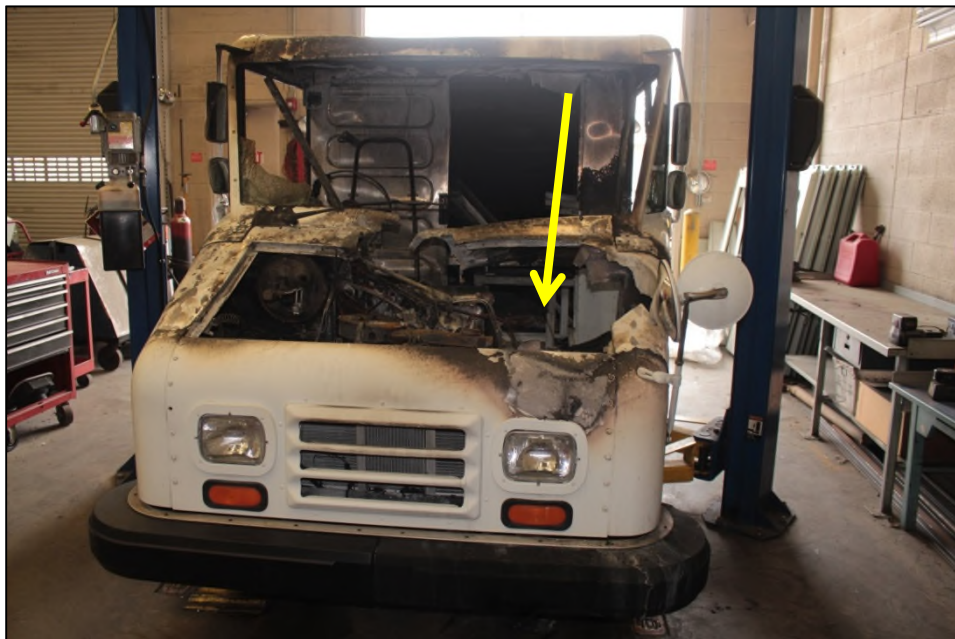
Photograph 4
Observed most severe damage to mail side of engine compartment.

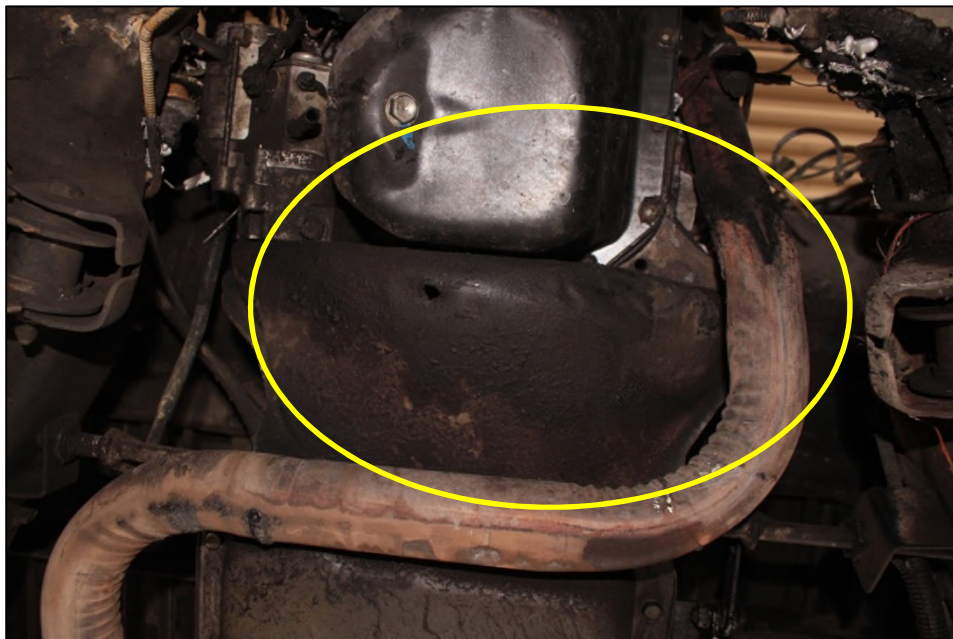
Photograph 8

Underside of the engine and oil pan, observed the fluid residue.

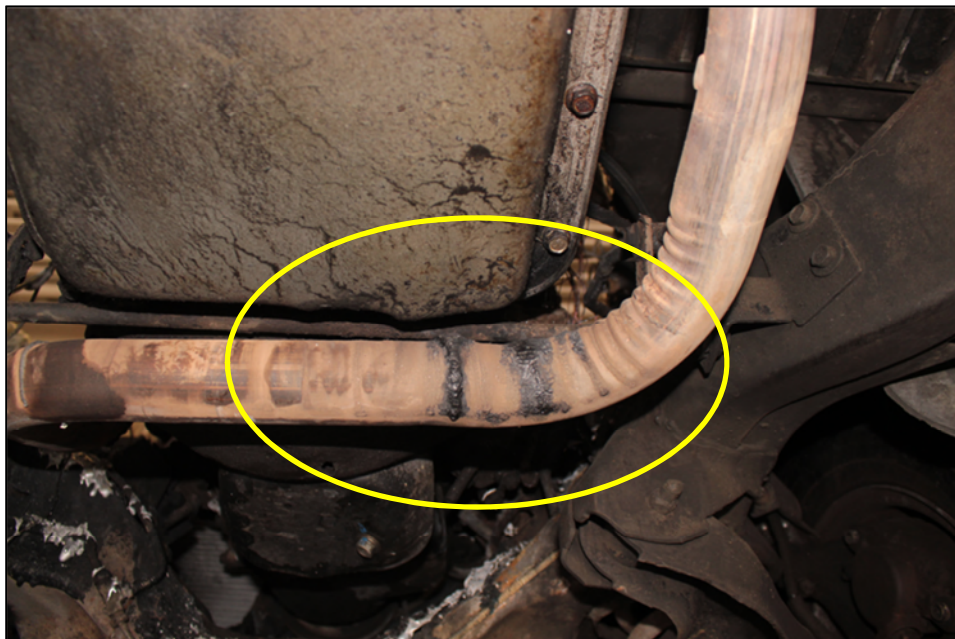
Photograph 10

A closer view of the fluid on the exhaust pipe.

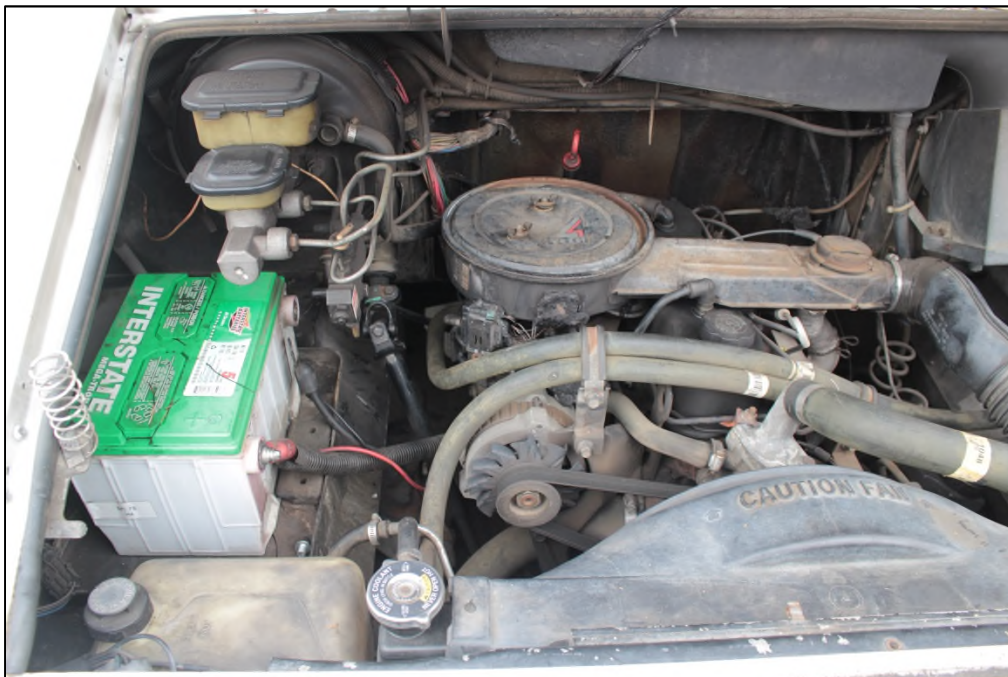
Observations indicated the source of a gasoline fuel leak was external to, and immediately below the air filter canister.

Photograph 2
Engine compartment. Fire area at air filter canister, near center.

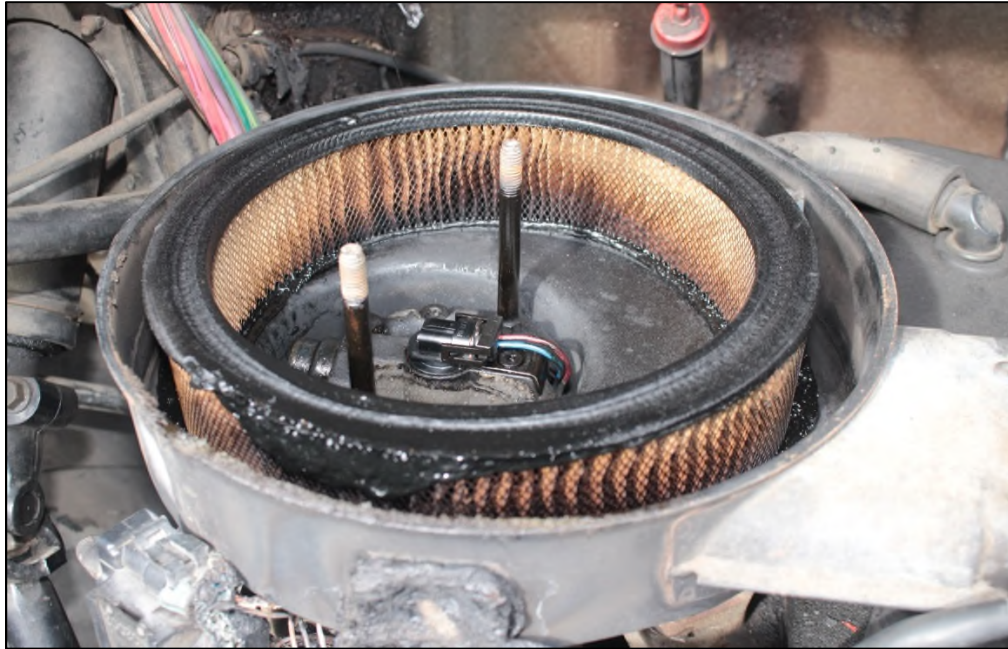
Photograph 3

Air filter scorched at bottom where rubber seal melted. Paper element relatively intact.

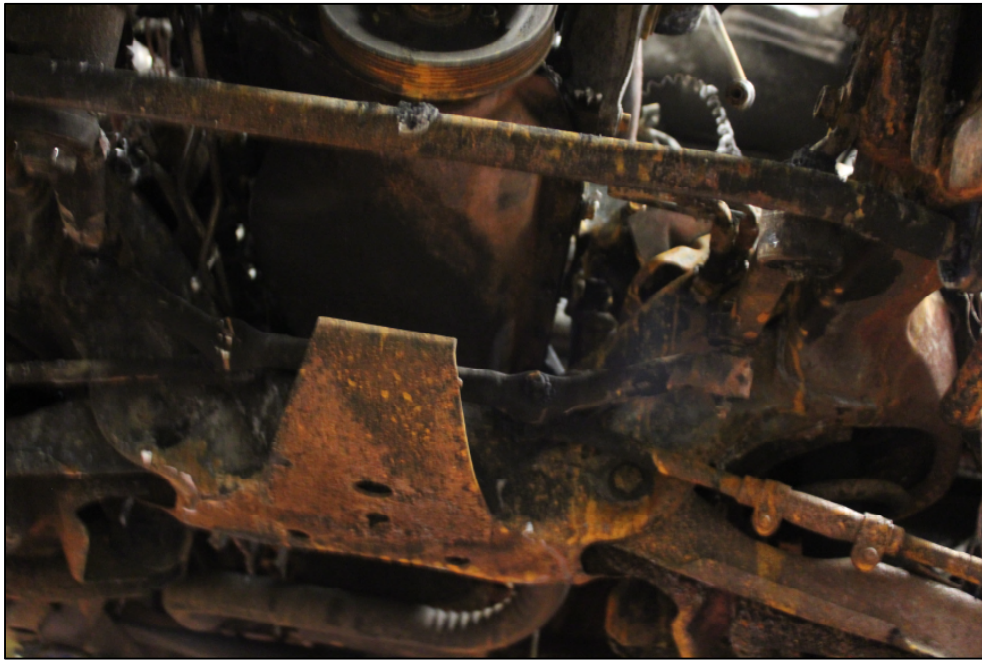
Photograph 7

View of undercarriage.

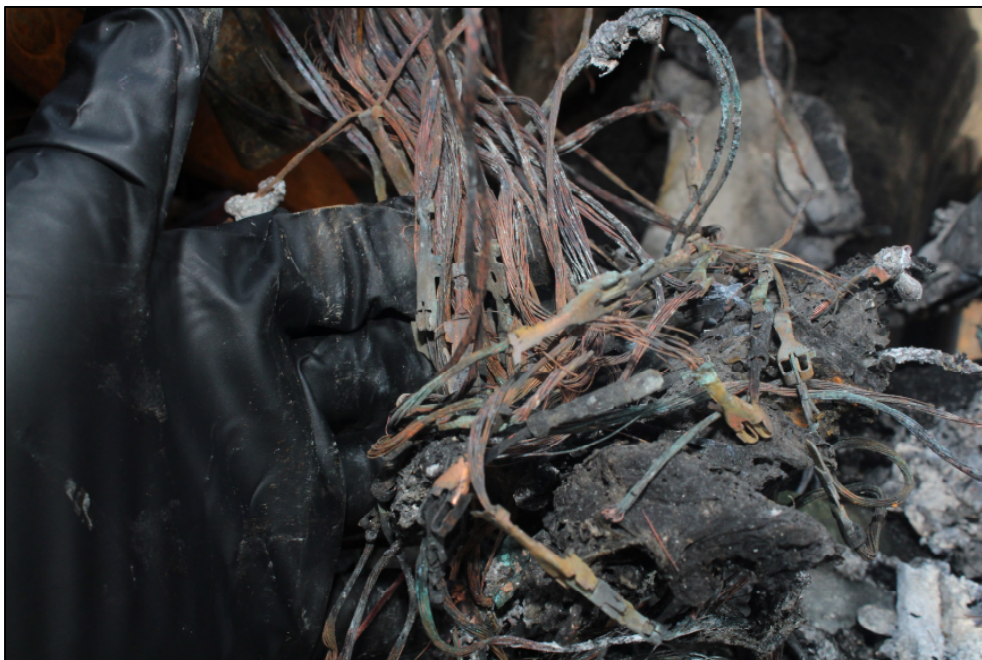
Photograph 8

Fuse panel area.

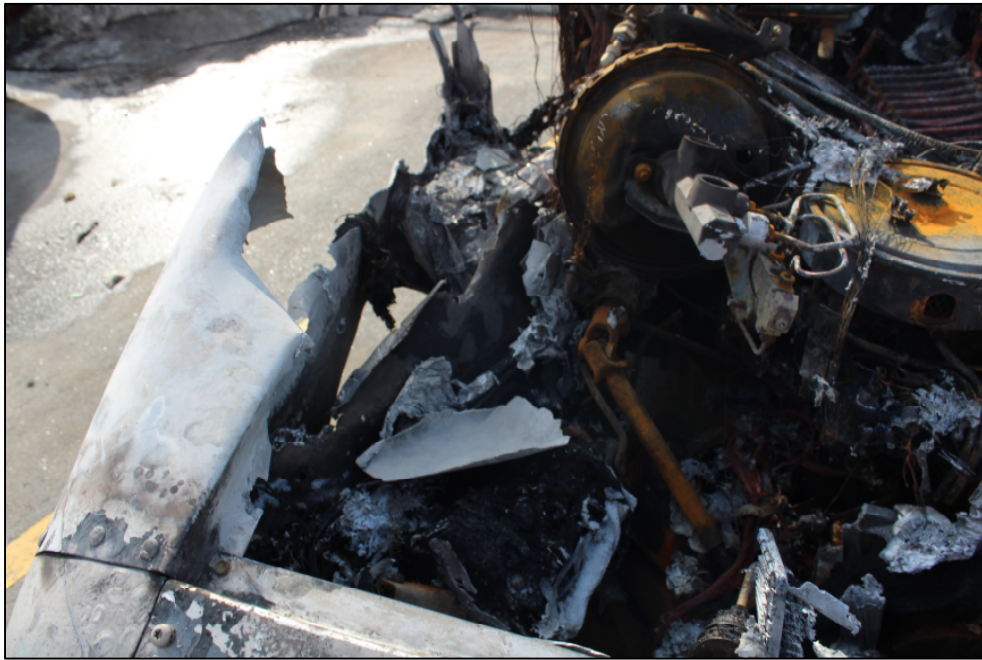
Photograph 10
Battery area.

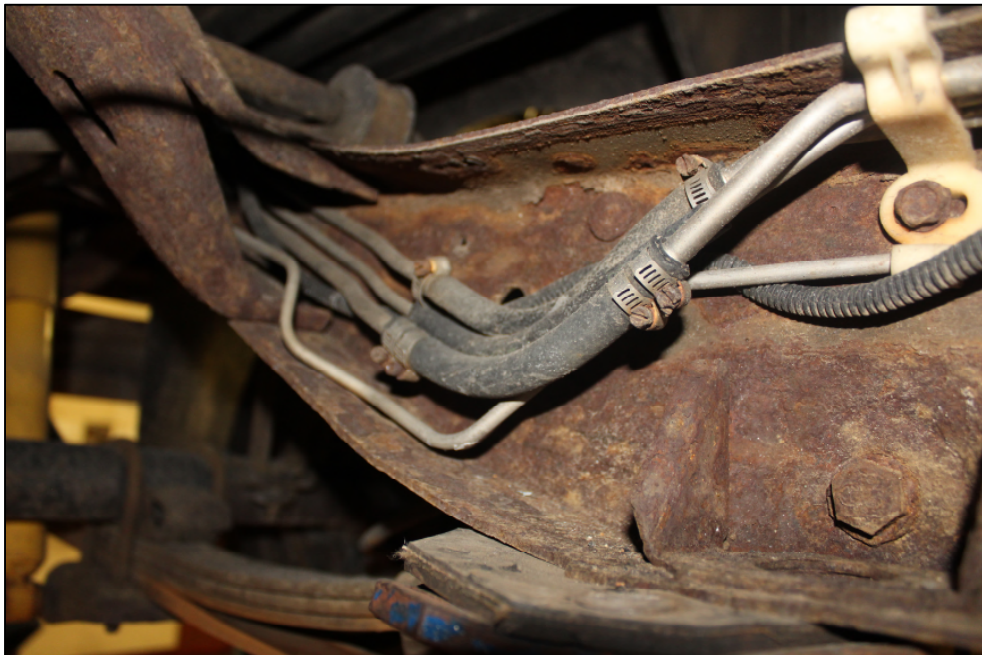
Photograph 11
Area where the rubber hoses were chafing.

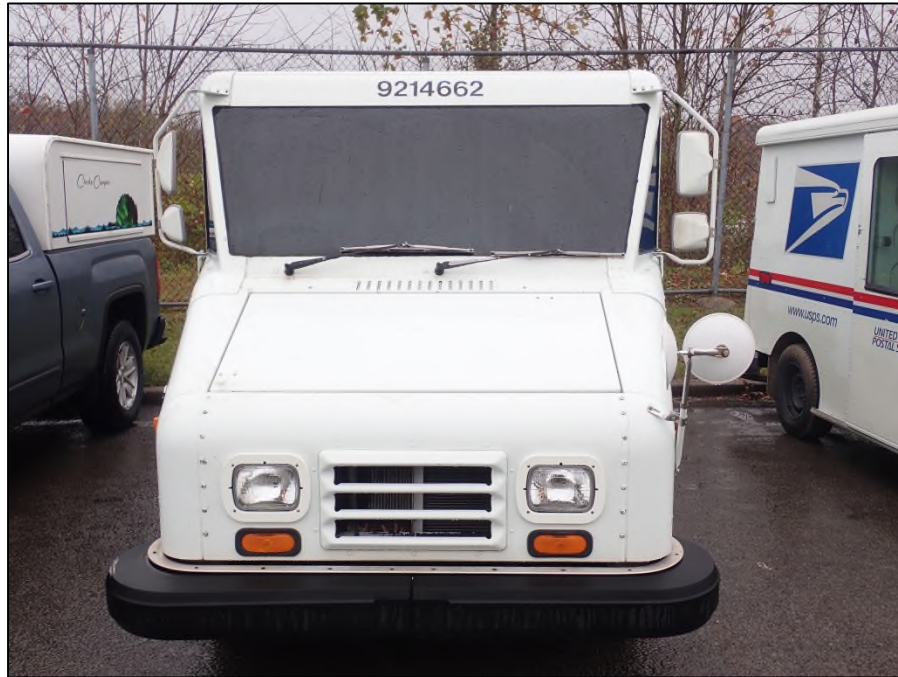
Photograph 1

A photograph of the front of the vehicle, the front windshield was darkened due to smoke/soot on the inside.

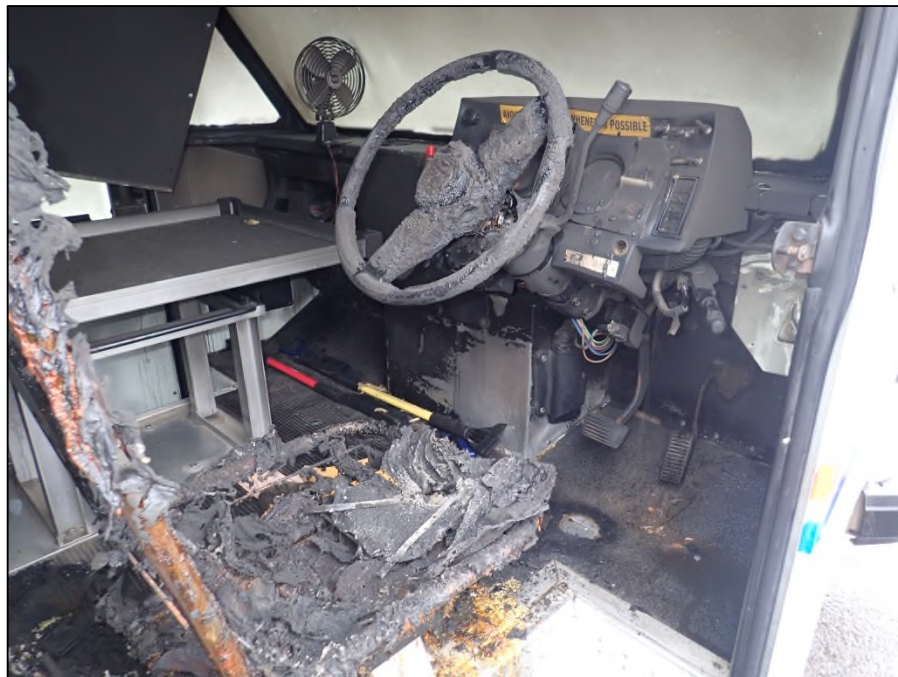
Photograph 2

The interior of the vehicle sustained moderate smoke/soot damage throughout. The driver's seat, steering column, dash and headliner directly above the seat sustained fire damage. The interior side of all the windows were severely stained with smoke/soot. The driver's seat sustained the greatest fire damage.

A photograph of the driver's compartment and area of fire origin.

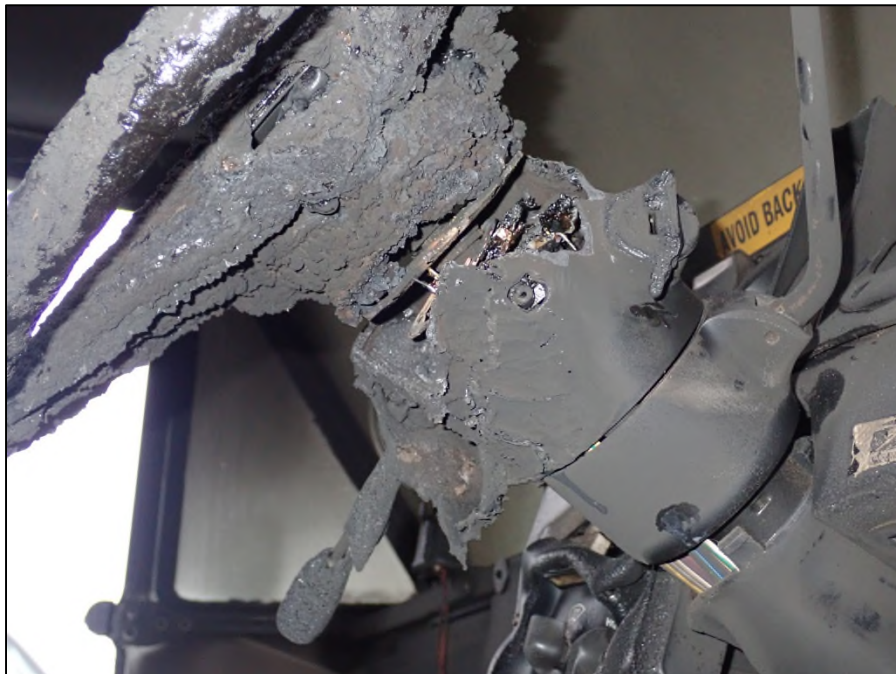
A failure of the turn signal switch could not be eliminated as a cause of the fire.

A photograph of the underside of the underside of the steering column.

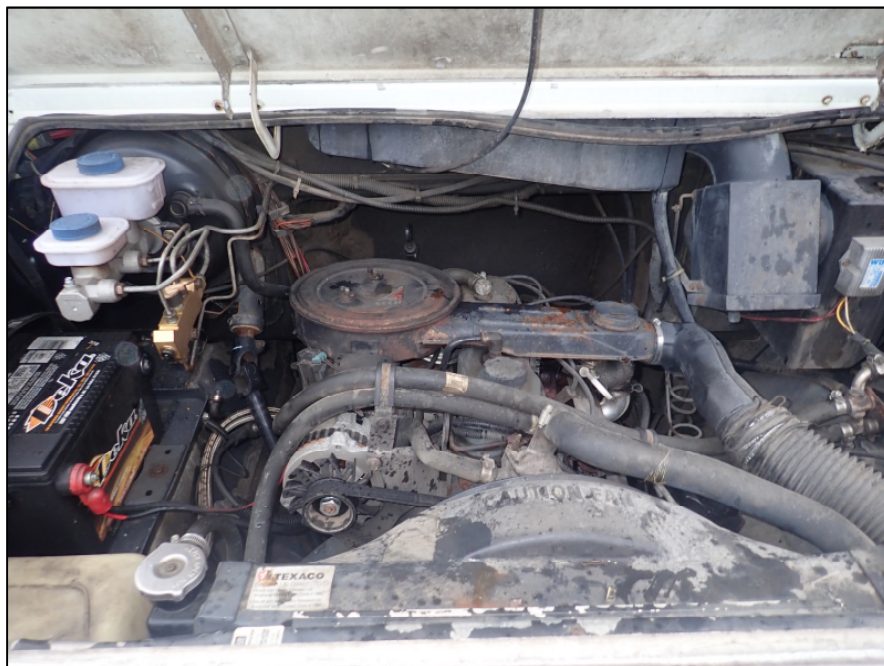
Photograph 6

No fire damage was observed within the engine compartment. The vehicle was equipped with a 2.5 liter four-cylinder engine with a high output ignition coil.

Engine compartment.

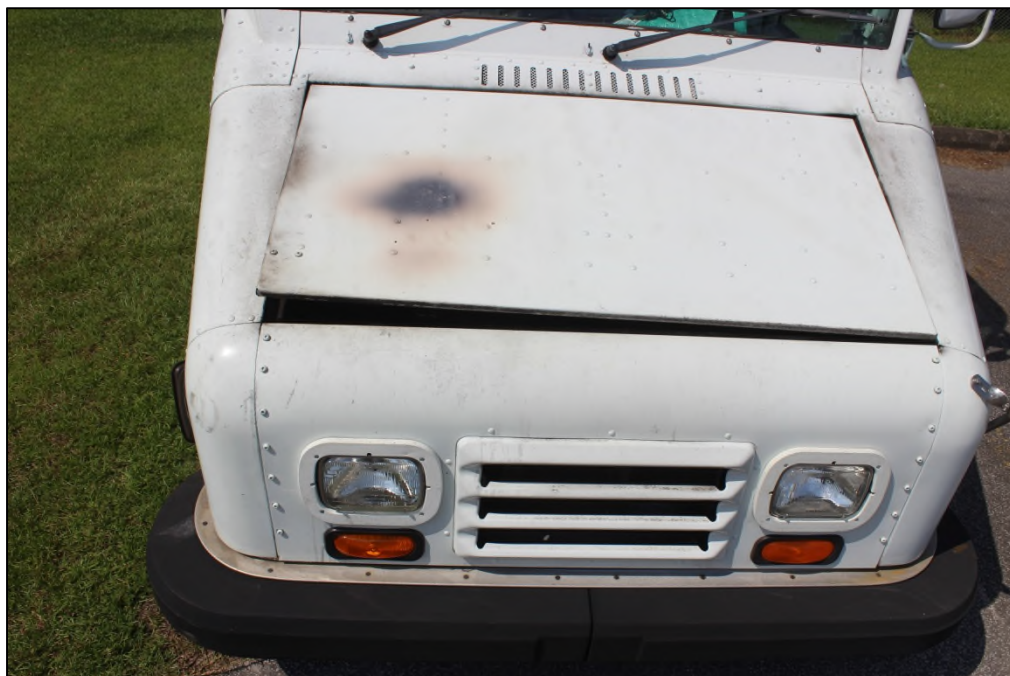
Photograph 2
Hood damage to vehicle.
